U.S. Department  
of Transportation

National Highway  
Traffic Safety  
Administration

Case Vehicle (A): 1999 Volkswagen  
Type: Jetta, 4-door sedan  
Driver: 32-year-old male  
CDC: 06-BDEW-7, 01-FDEW-3

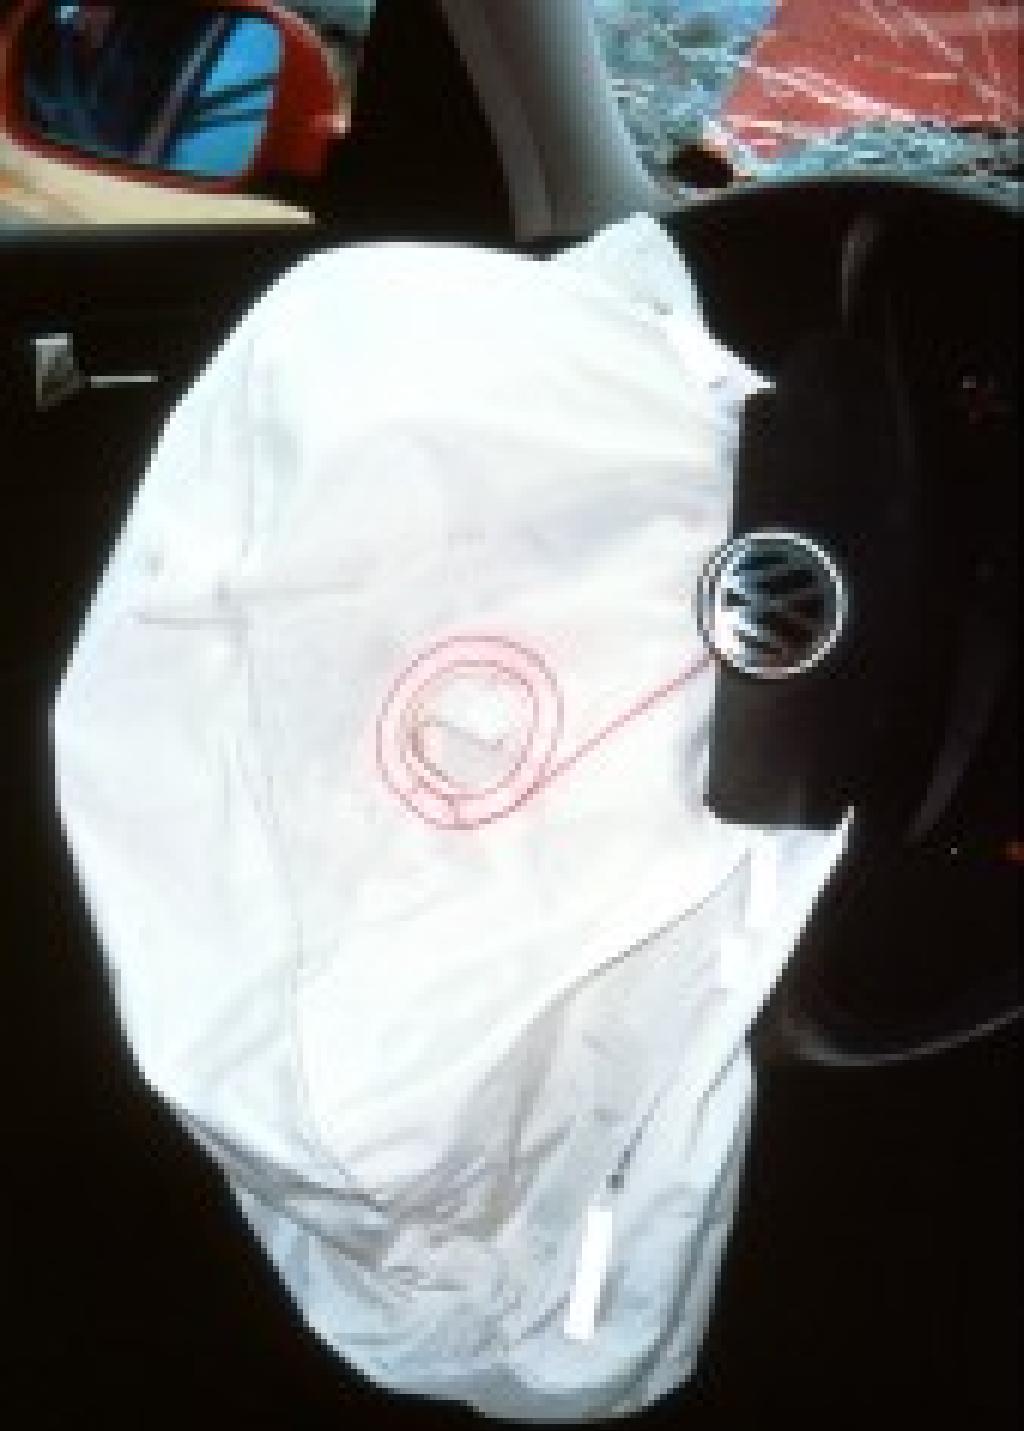
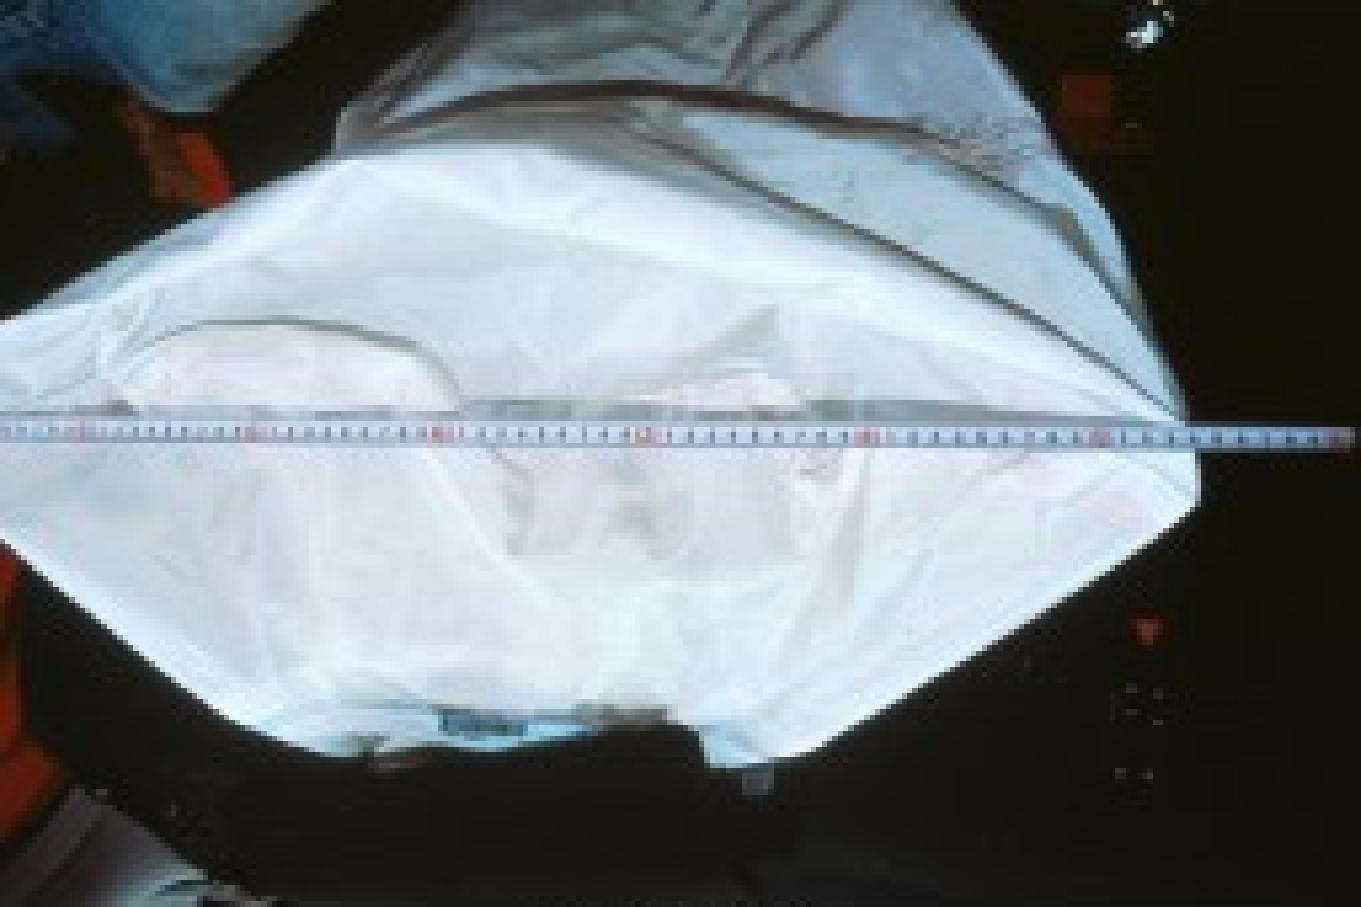
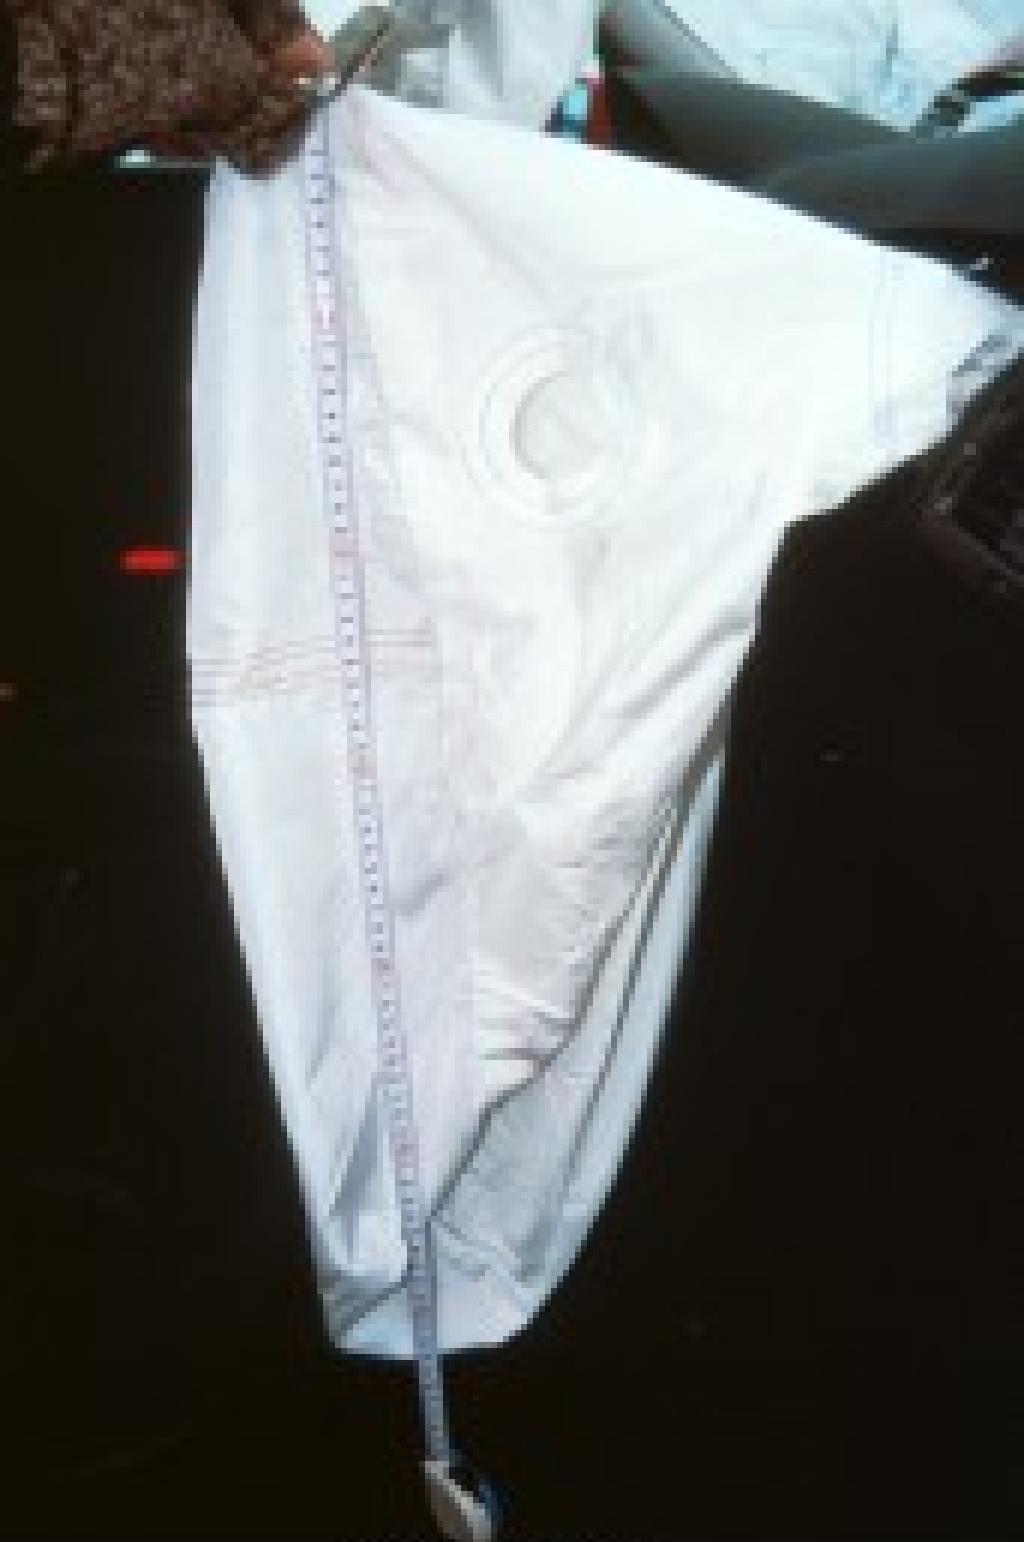
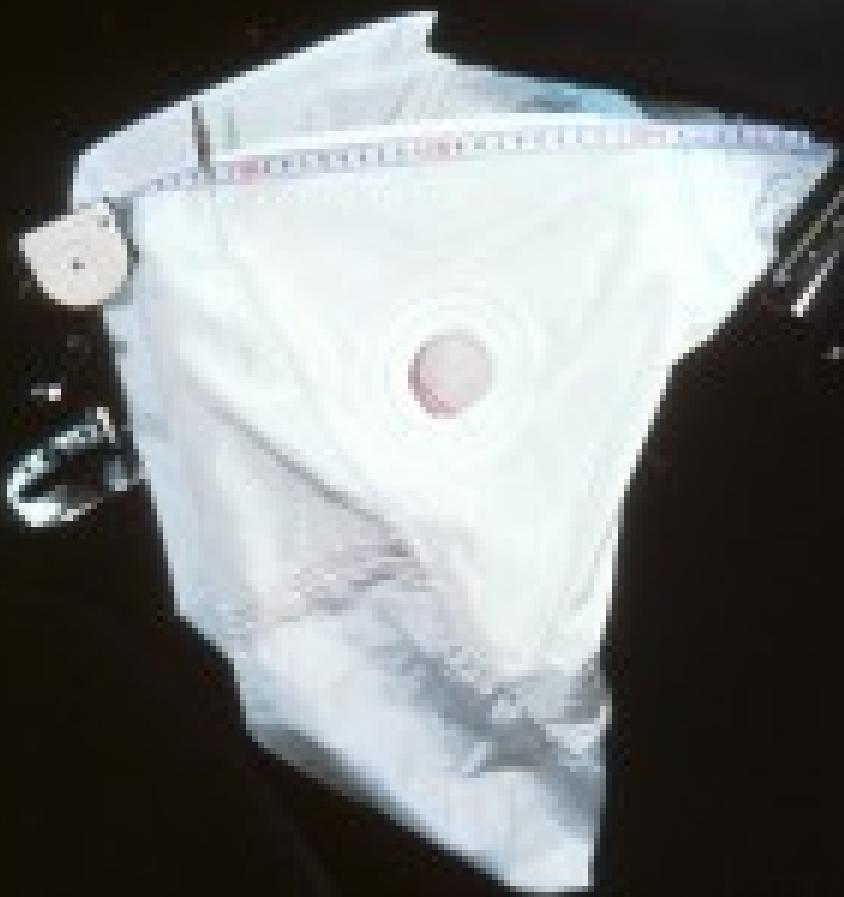
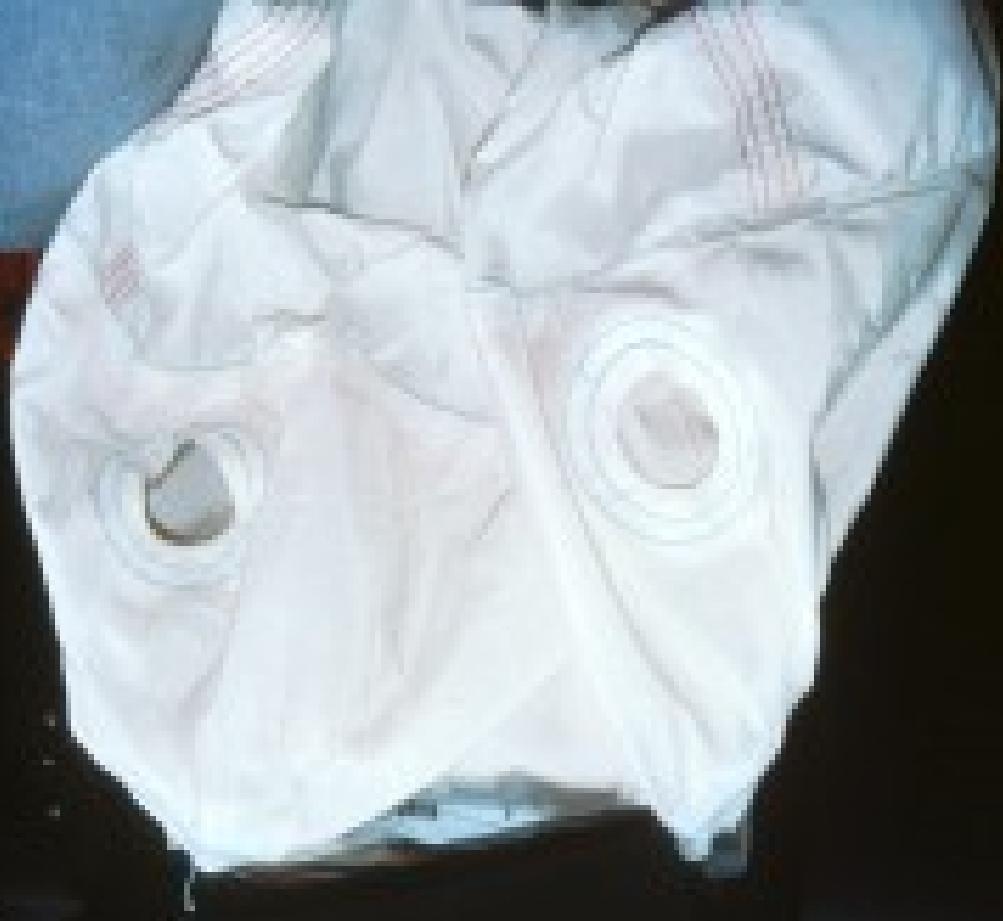
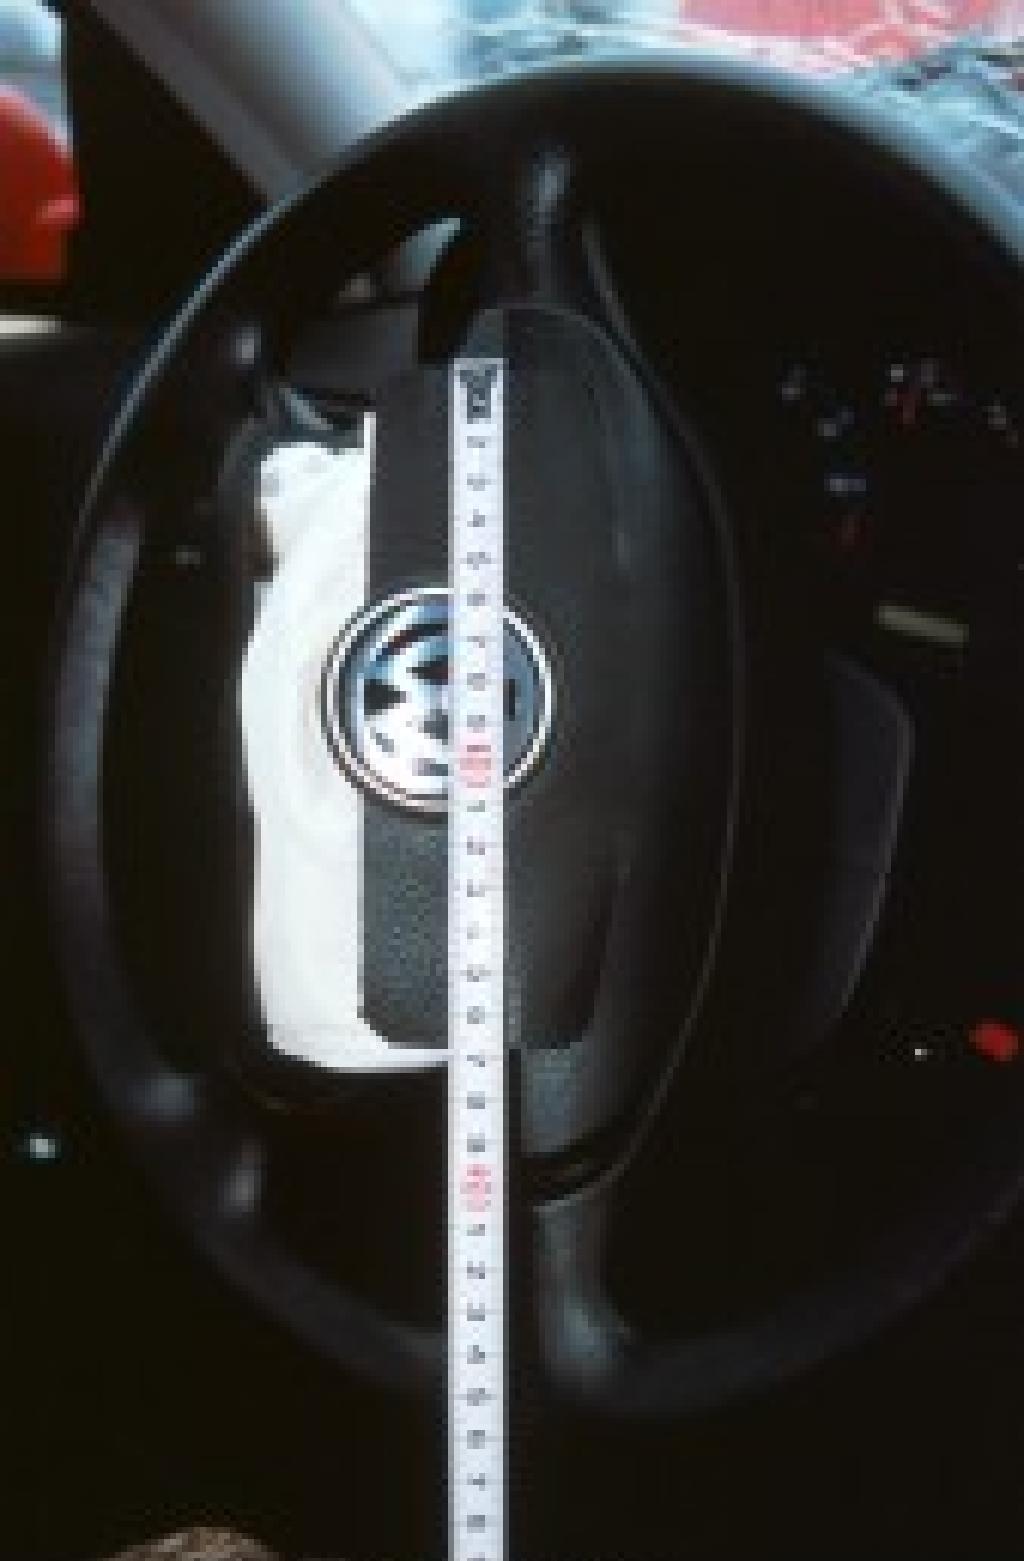
(Slides 19, 20, 21, 22, 23, 24) This vehicle was equipped with both steering-wheel and passenger frontal-impact airbags, and both deployed during the frontal impact. No damage was noted to the airbag skins or (slides 25, 26, 27, 28) to the module doors/flaps. (Slide 29) No occupant contact marks were noted to the airbag module doors/flaps. (Slide 30) The upper half of the steering-wheel rim was deflected slightly forward and there was slight deformation of the steering-wheel spokes. There was minor rotation of the steering column to the right. The driver seatback recliner mechanism did not hold. (Slides 31, 32) The left rear door, the door hardware, the armrest, the left-rear glass, the left B-pillar, both rear roof siderails and the back-light header were deformed. The shelf below the back-light and the rear seatback were damaged by intrusion. (Slides 33, 34, 35, 36, 37) No contact points were noted on the left-roof siderail, the left upper A-pillar, or the left-front door interior panel. No damage was noted to the upper and mid instrument panels. The following intrusions were noted and measured.

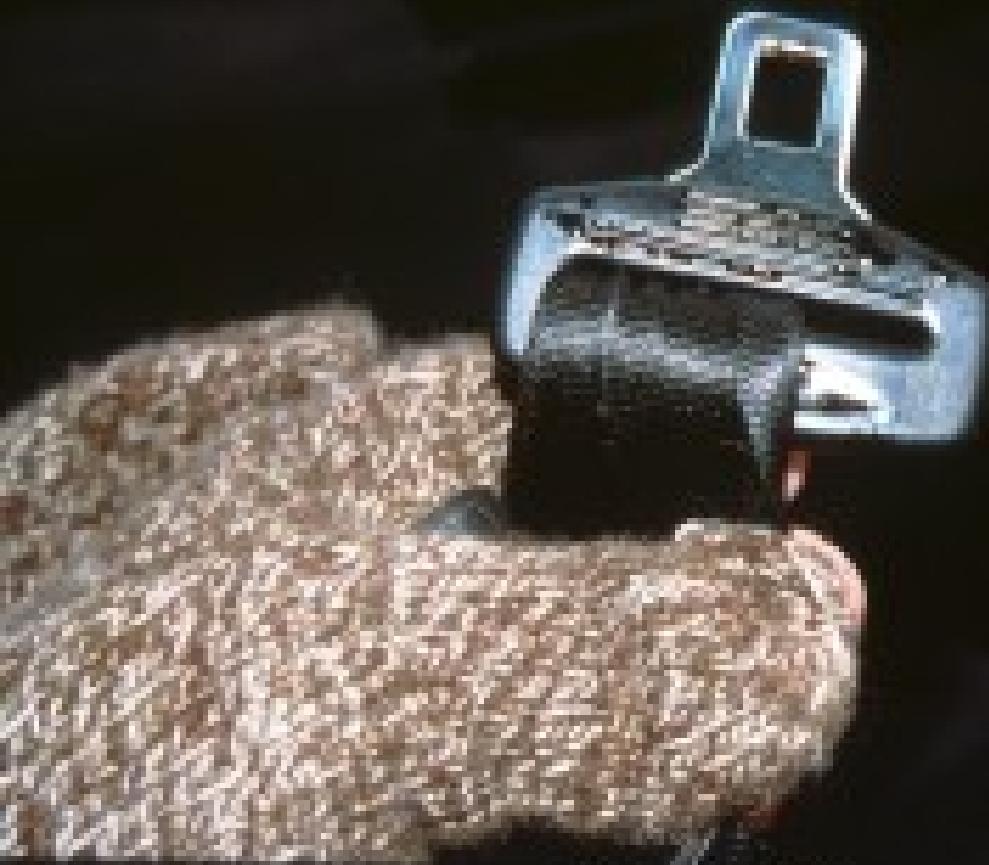
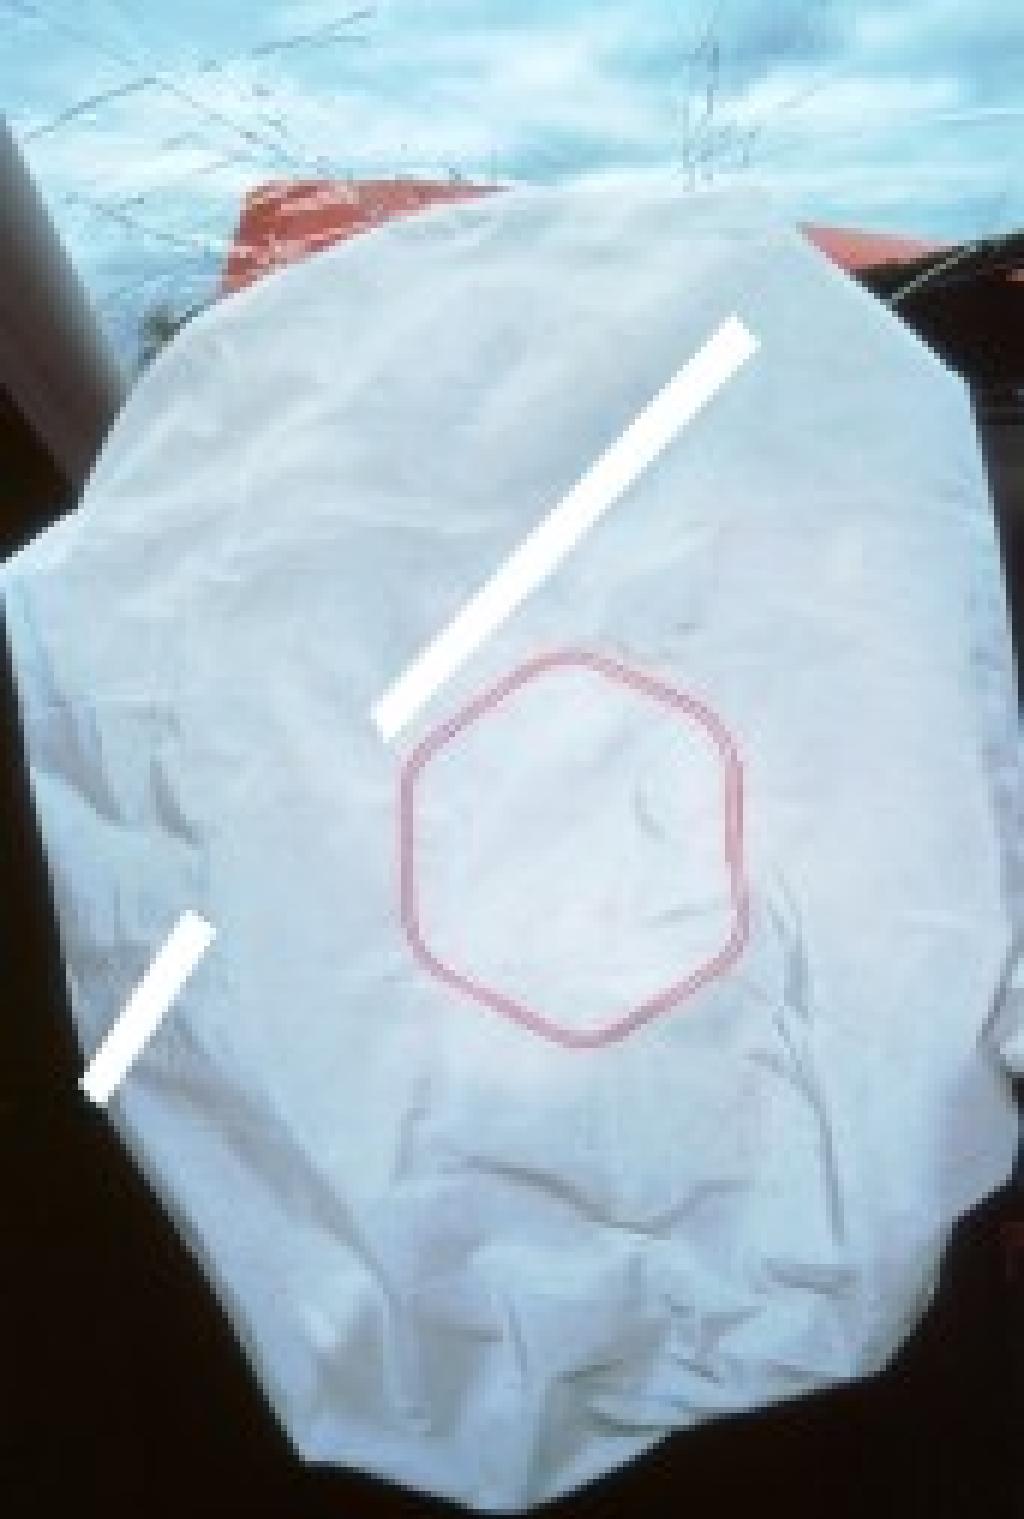
The 5-ft, 11-in, 185-lb, 32-year-old male driver (slide 38, 39) was wearing the available three-point belt, as indicated by a webbing imprint on the plastic continuous loop of the seatbelt tongue assembly, and (slide 40) the steering-wheel airbag deployed. During the initial rear impact, he moved rearward into the seatback. (Slides 41, 42) During the frontal impact, he moved forward and slightly to the right into the shoulder belt and the airbag. He sustained a Grade-I laceration of the spleen, possibly from contact with the door. He sustained a contusion to his left hip, probably from loading by the lap belt, but possibly from contact with the door interior. (Slides 43, 44) He sustained an abrasion to the right shin, probably from contact with the knee bolster. He also sustained a fracture of the right distal 5<sup>th</sup> phalanx, possibly from hand contact with the instrument panel, although no contact point was noted that could be associated with this injury.
